We have concluded our assessment of the existing buildings and site conditions at this former middle school campus. We have established probable costs of construction to remediate and renovate existing conditions and to construct a new 55,000 square foot addition. The addition has yet to be programmed, but is necessary to develop a middle school that will achieve functional equity with a typical 1000 to 1200 student middle school campus. Based on this premise, we conclude that the probable cost of construction to remediate and renovate the existing buildings and provide for the required new construction is \$26,900,000. Because current 1000 to 1200 student middle school campuses cost approximately \$20,000,000 to construct, we recommend that the District consider replacing this campus in lieu of renovation. Key factors to consider when contemplating renovations and additions to this campus are as follows:

Rimkus Consulting Group (Rimkus) was retained by Chubb Insurance Company to determine the limits of intended work to be performed by the contractor and to determine the extent of damage to the building outside of those limits as a result of work being performed by the contractor.

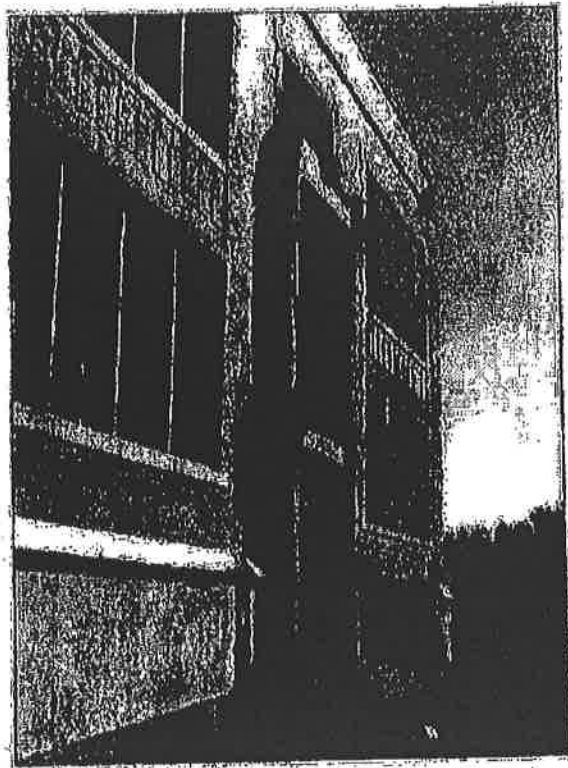
Photograph 18

- Inspection of the west end of the main building indicated the concrete columns at the sides of the west exit ended near the level of the first floor, with masonry columns extending above that level (Photograph 17). We observed cracking in the masonry columns on both sides of the exit above the first-floor level. Concrete columns had been installed at the exterior of the main building for the walkway (Photograph 18).

View of exterior columns for walkway at west end of main building, looking south.
